## Freightliner Sprinter Emblem Delamination

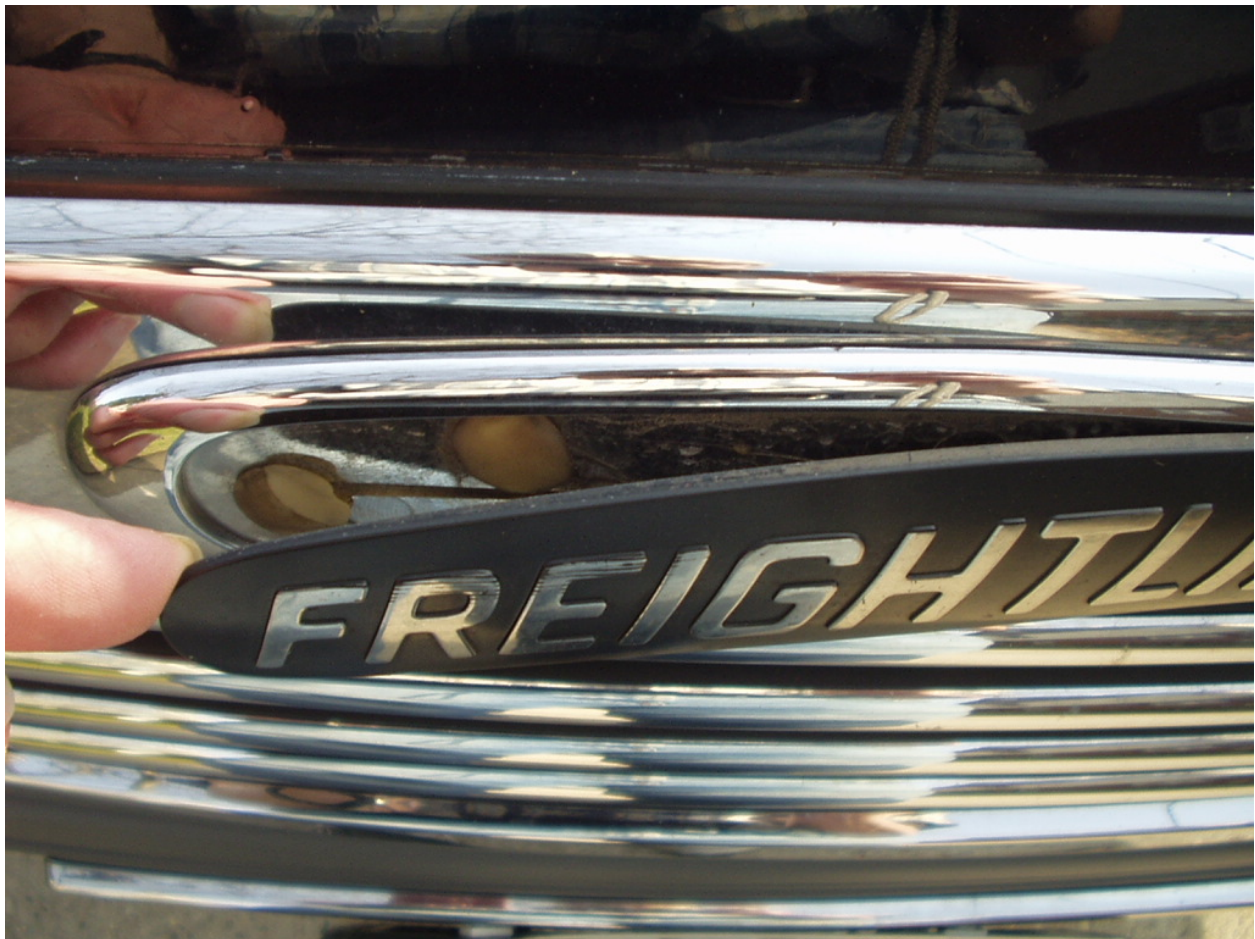
Emblems ready to fall off are noticeable by a gap between the plastic-chrome and the black plastic of the emblem. There are 6 glue-dots holding the emblem on. When 3 to 4 are loose, either check regularly or complete the delamination by carefully prying it off with a large-blade screwdriver.

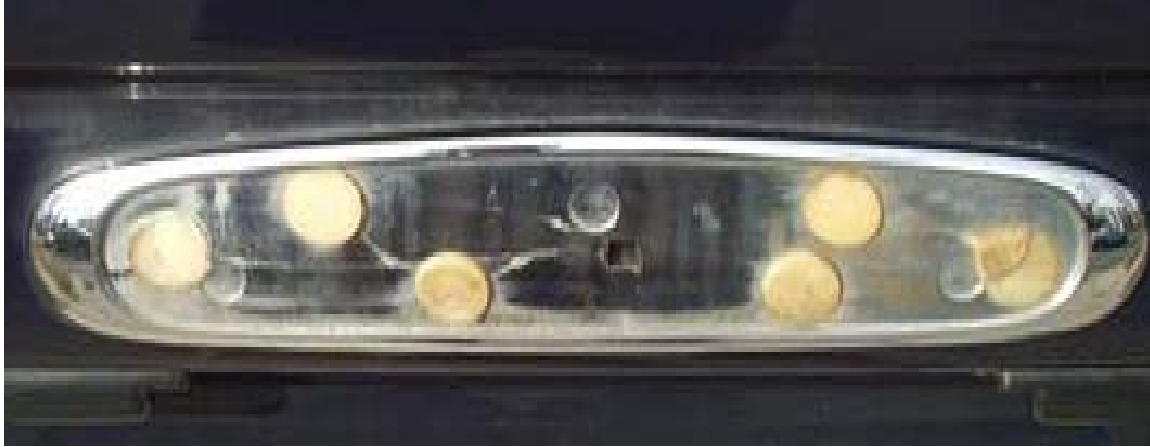
Once the emblem is off, note that the glue dots are always well attached to the chrome-plastic base. Do not take these dots off, as they provide the proper spacing between the base and the face of the emblem. Clean these dots with a non-grease cleaner.

NOTE: the dots often have a thin film that is not fully attached to the main glue dot. Either cut this film off or make sure that the contact glue is on all sides of the film.

Apply contact glue to both the dots and the back side of the emblems. After curing, flip the emblem into position from the bottom up. Apply pressure, and you are done!

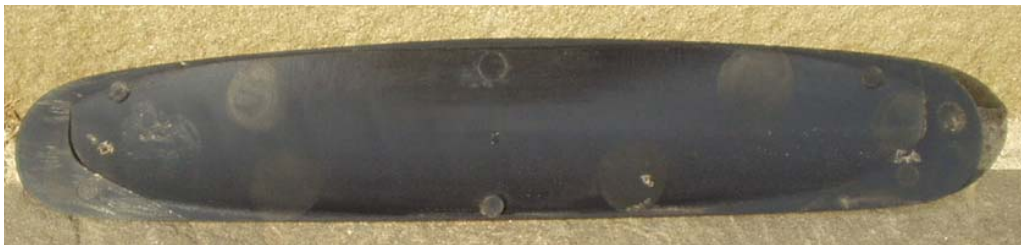
Also clean the back of the emblem. Note that there is no part number for the emblem. Apparently the emblem is sold only as part of complete unit:

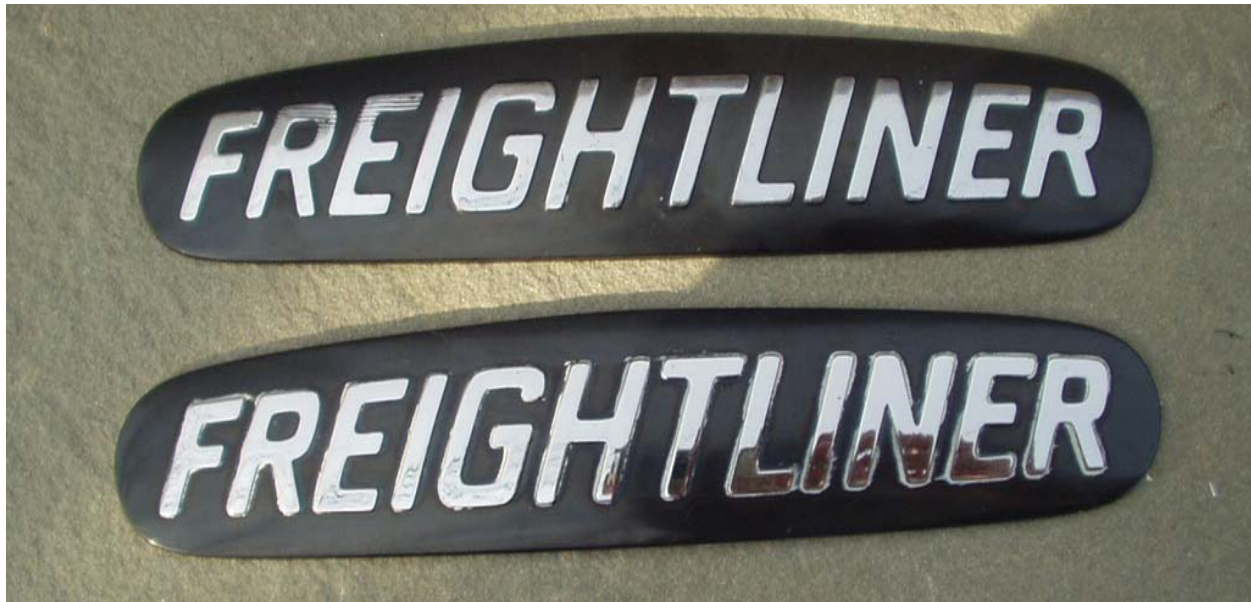
If you are (un)lucky enough to have both emblems delaminate at the same time, note that they are identical, but the bases that they attach to are not. In my case, the front emblem had scratches, so I move it to the back and brought the rear to the front:
